Effect of Surface Treatments on Fracture Strength of Zirconia Core

¹Yusra A. Ibraheem, ²Zahraa N. Alwahab MSc., PhD

^{1, 2}Department of Dental Technologies, College of Health and Medical Technologies, Middle Technical University, Baghdad, Iraq.

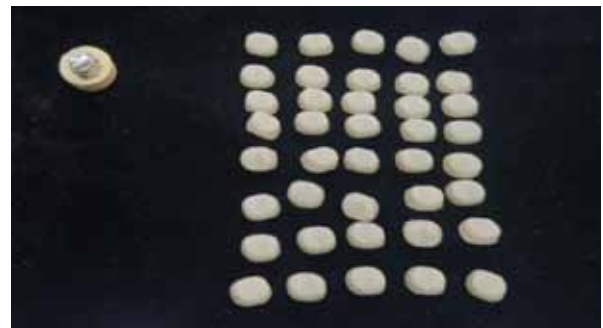
Figure 1: Zirconium cores.

A total of twenty-four zirconia cores were prepared from pre-sintered zirconia blank. They were designed and cut by the CAD-CAM system. Based on the surface treatment and veneering materials zirconium cores were divided after standard surface sandblasting procedure into three groups (n=8) as shown in figure (1).

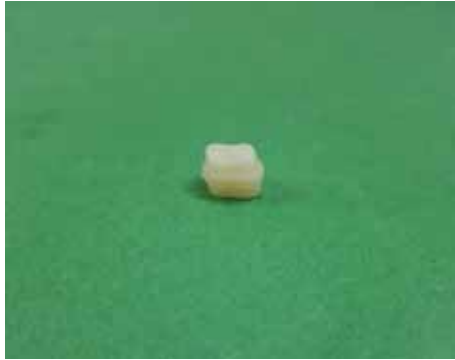
Figure 2: An ideal pre-prepared plastic right maxillary first molar.

An ideal pre-prepared plastic right maxillary first molar (Nissin Dental Products, Kyoto Japan) with deep chamfer finishing line (0.8mm), (2mm) reduction occlusally was utilized for the construction of a master metal die as shown in figure (2).

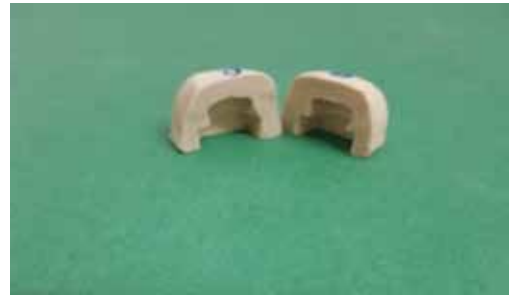
Figure 5: Silicone index.

Group C, specimens treated with Hydrofluoric acid of 9.5% and the application of bonding agent, then veneered with 3M ESPE Filtek (Packable P60 Composite Resin). In group (A) a silicon index was fabricated, a putty condensation silicone impression material (Zhermack, Italy) was used to fabricate a silicon index, an impression was taken to the previously veneered composite crown to control the thickness of veneering ceramic as shown in figure (5). While for the application of veneering ceramic on zirconium core, the layering technique was used by mixing ceramic powder (50 mg) of IPS Ceram, dentin A3 powder with a special liquid to produce the desired creamy consistency of ceramic, then the ceramic was applied to the prepared core surface by a brush, then sintering process was achieved in the ceramic furnace according to the manufacturer instructions.

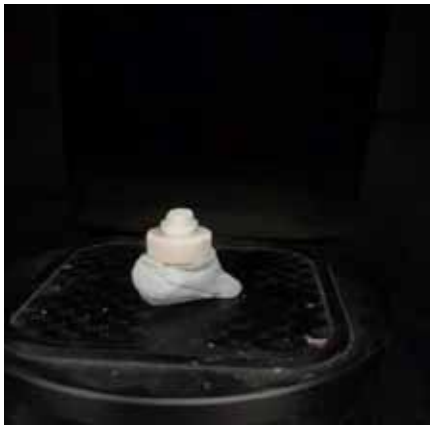
Figure 3: The plastic die was placed on the stable scan stage.

The plastic die was sprayed with dental scan spray to inhibit reflection of light during the scanning process and the plastic die was placed inside the dental scanner unit (DOF, full HD, 5M pixel; Korea) and fixed on scan stage by special clay as shown in figure (3).

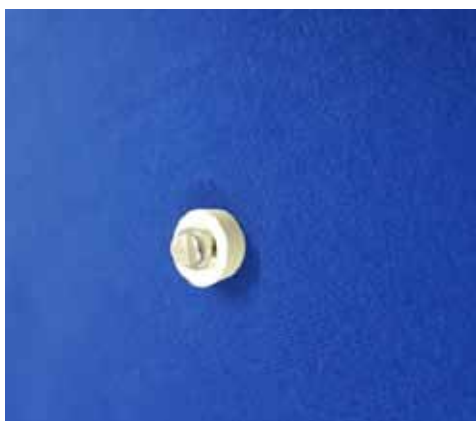
Figure 4: The final metal die with stone base.

The digital model of the die transferred to the CAM software to start the dry milling process of the metal die by using the milling unit which was loaded with the cobalt-chromium disc (10mm) [Interdent, Travagliato (BS) Italy]. The base for the metal die was constructed from dental stone type IV (Azarbal et al, 2018), this base allows the proper position of the metal die during scanning. Then the dental stone was mixed according to manufacturer instruction, vibrated, and poured to 4mm below the cemento-enamel junction (Abdulkareem and Ibraheem, 2016) as shown in figure (4).
